Chapman Brook Blackwood River Basin

A snapshot of the condition of the Chapman Brook

Chapman Brook Blackwood River Basin Lower Blackwood Catchment

A Snapshot of the Condition of Chapman Brook 2012/2013

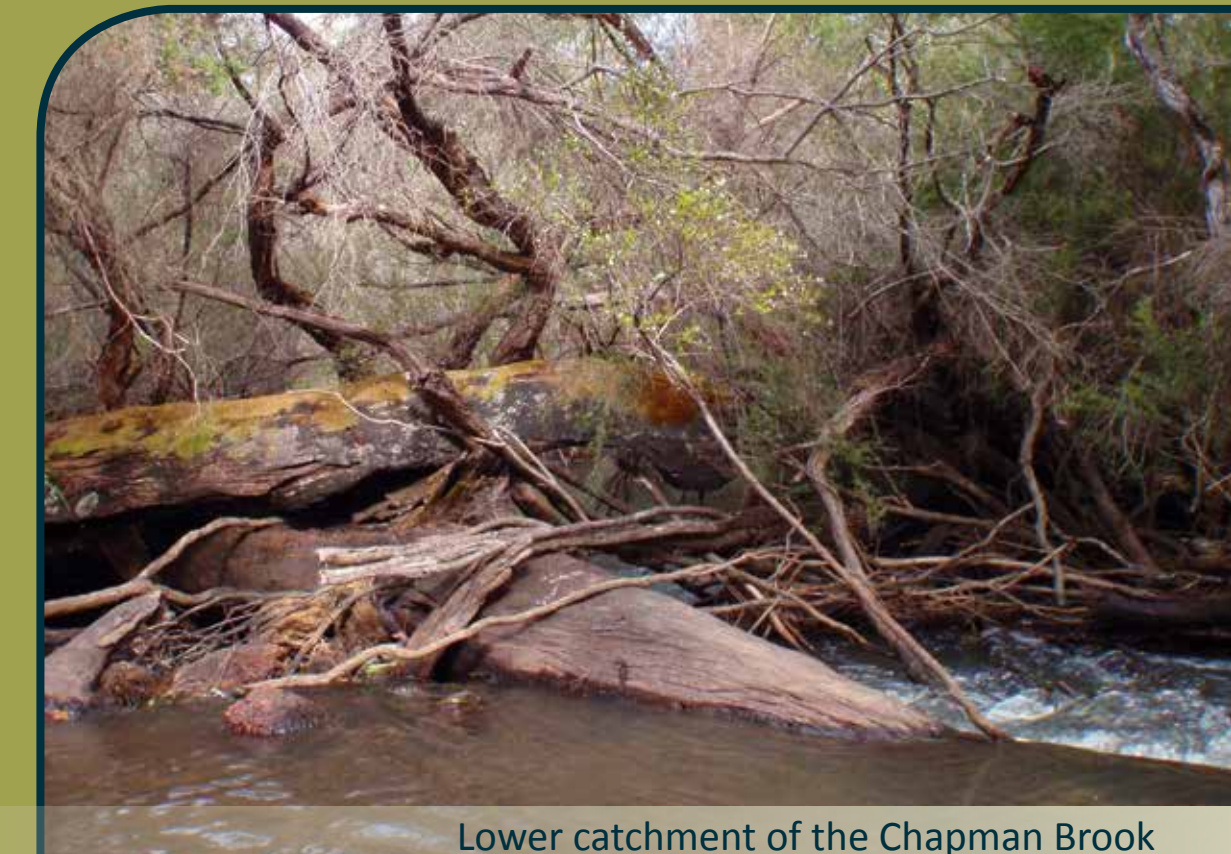
Lower catchment of the Chapman Brook

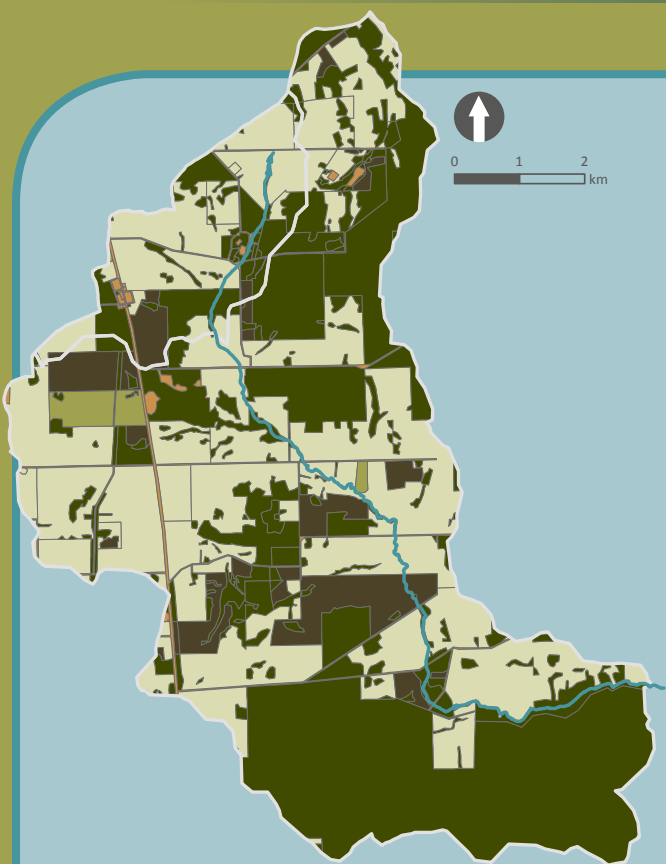
LAND USE 2007 (DoW 2012)

The Chapman Brook, in the lower catchment of the Blackwood River, extends 20 km from the top of catchment to the confluence with the Blackwood River. The assessment covered 15 km of the Brook with a catchment area of 65 km².

- 46% conservation/minimal use
- 43% grazing
- 7% intensive/irrigated agriculture
- 2% urban/transport/mining
- 1% plantation forestry.

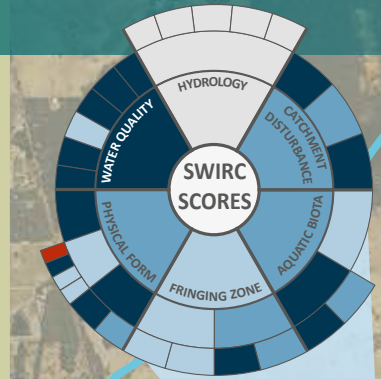
Based on the 2012/2013 assessment, the Chapman Brook was generally in good condition, with the majority of the broad ecological theme scores (inner ring of the SWIRC scoring diagram) being categorised as 'largely unmodified' or 'slightly modified'. The indicators contributing to theme scores (the middle and outer rings) were all within the 'largely unmodified' to 'moderately modified' categories with the exception of three indicators that showed 'severe modification'; these are summarised overleaf.
