McLeod Creek Blackwood River Basin

A snapshot of the condition of the McLeod Creek

This snapshot provides a baseline summary of waterway condition for the McLeod Creek, based on assessments conducted in 2012 to 2013. A number of key values and threats to the system are highlighted.

A Snapshot of the Condition of McLeod Creek 2012/2013

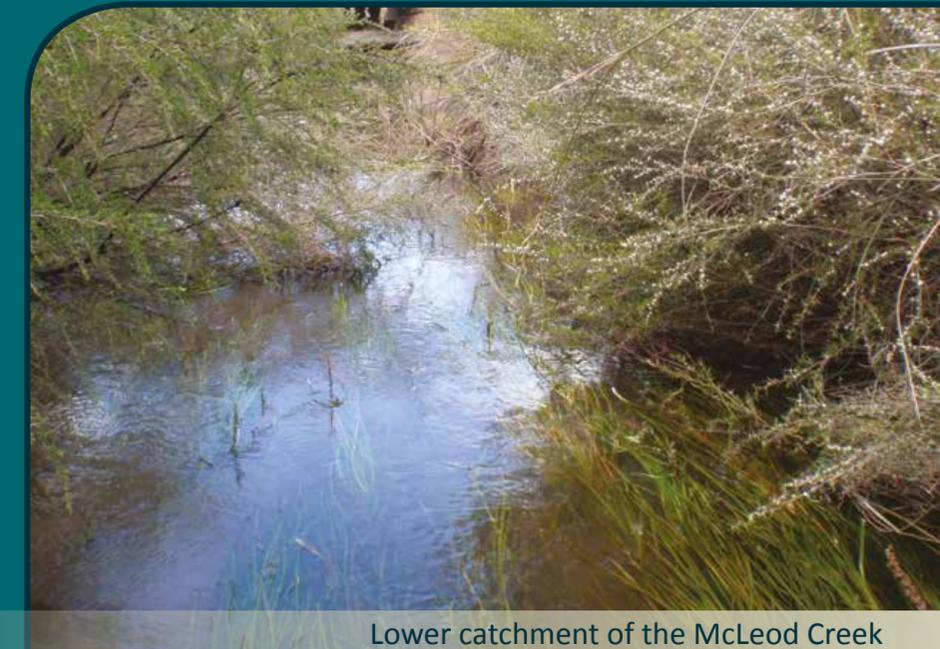
Lower catchment of the McLeod Creek

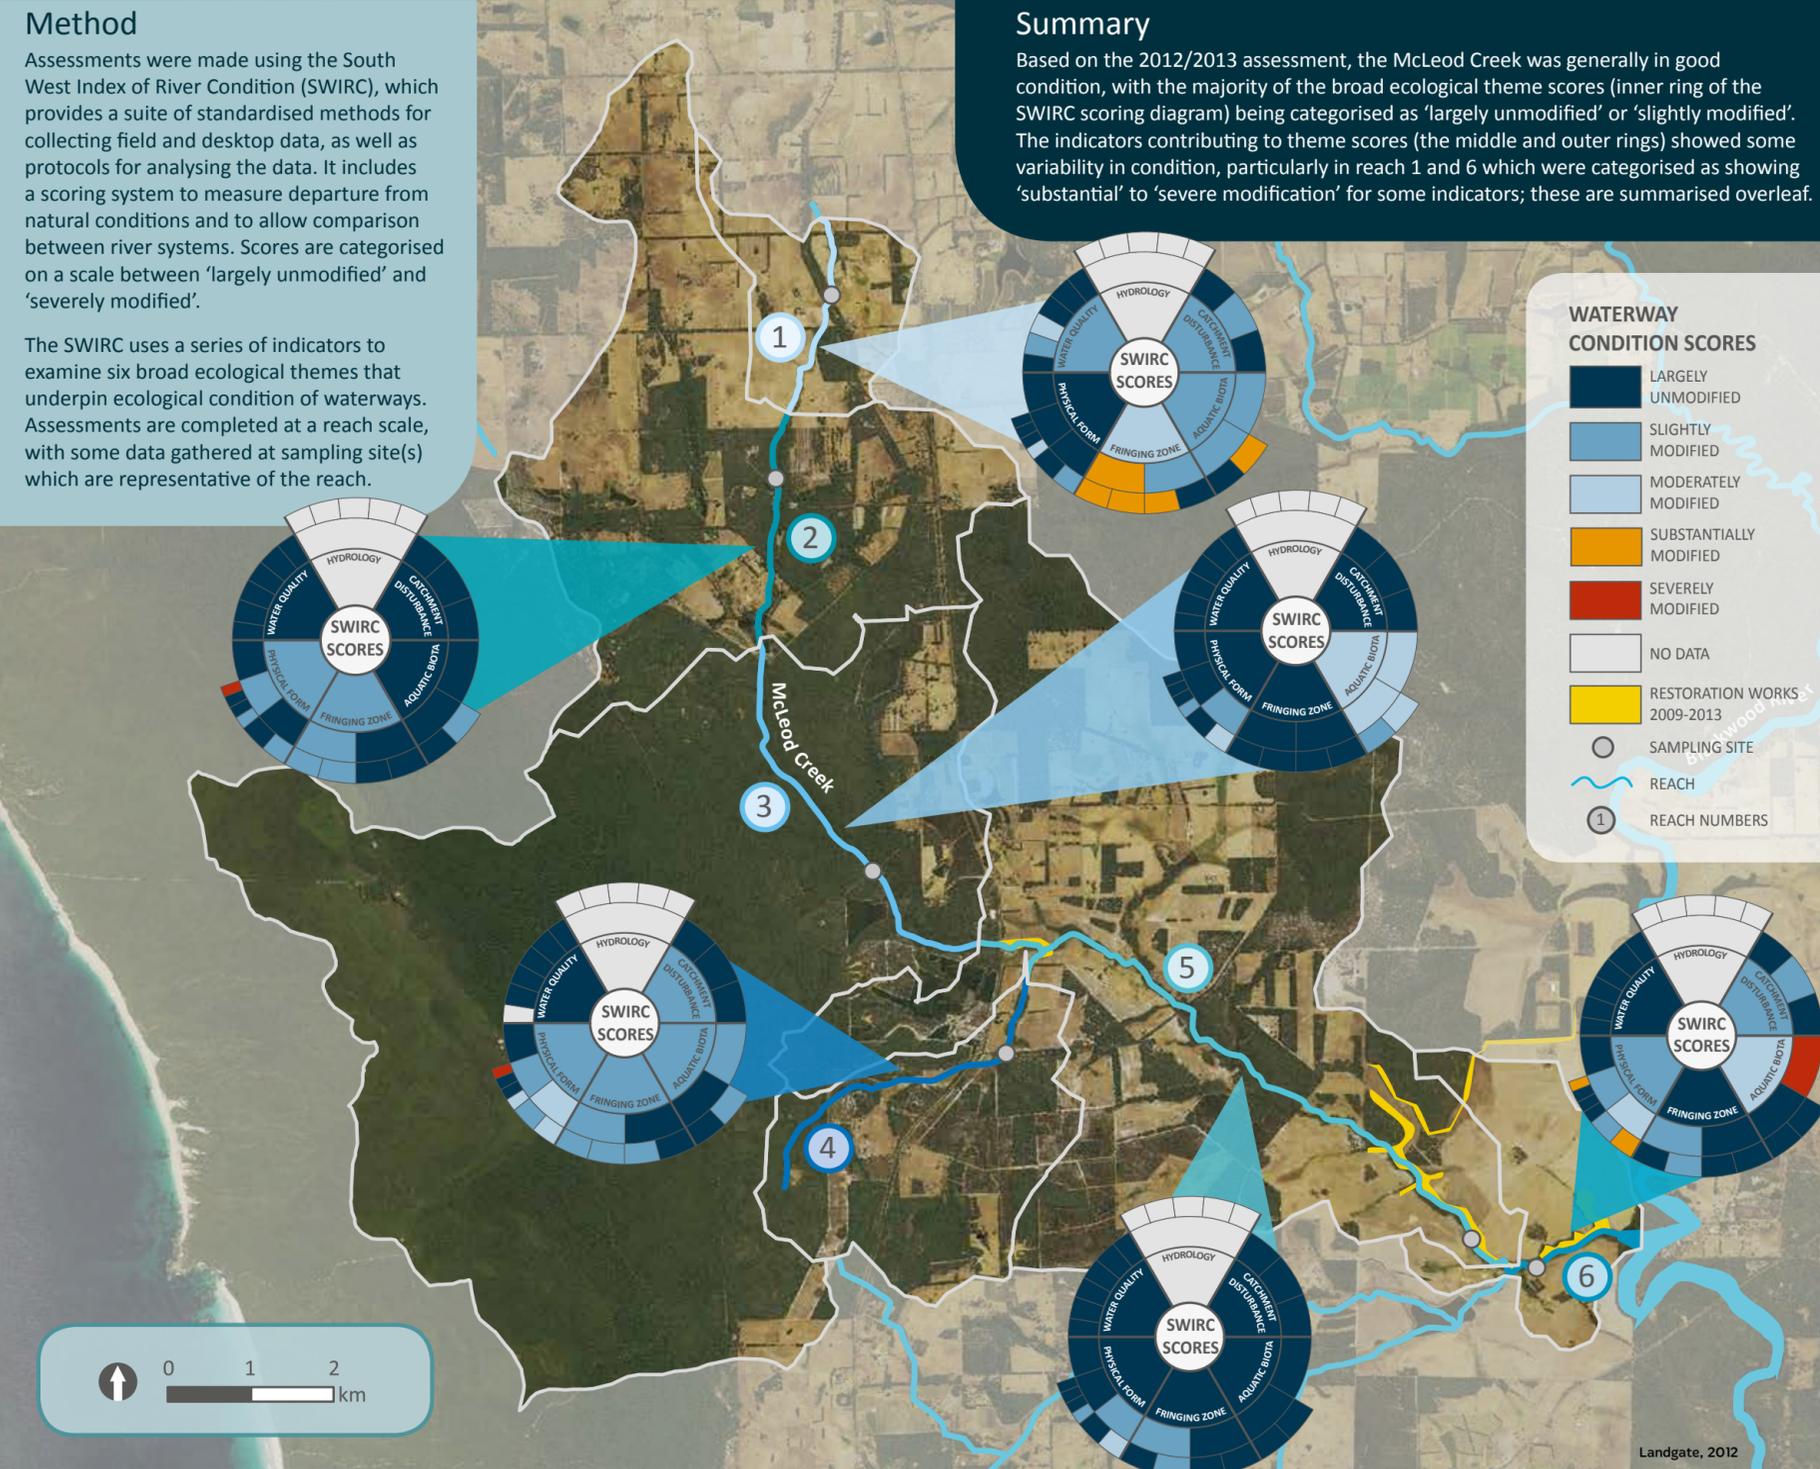
Based on the 2012/2013 assessment, the McLeod Creek was generally in good condition, with the majority of the broad ecological theme scores (inner ring of the SWIRC scoring diagram) being categorised as 'largely unmodified' or 'slightly modified'. The indicators contributing to theme scores (the middle and outer rings) showed some variability in condition, particularly in reach 1 and 6 which were categorised as showing 'substantial' to 'severe modification' for some indicators; these are summarised overleaf.

Assessments were made using the South West Index of River Condition (SWIRC), which provides a suite of standardised methods for collecting field and desktop data, as well as protocols for analysing the data. It includes a scoring system to measure departure from natural conditions and to allow comparison between river systems. Scores are categorised on a scale between 'largely unmodified' and 'severely modified'.

The SWIRC uses a series of indicators to examine six broad ecological themes that underpin ecological condition of waterways. Assessments are completed at a reach scale, with some data gathered at sampling site(s) which are representative of the reach.
