Upper Chapman Brook Blackwood Basin

A snapshot of the health of the Upper Chapman Brook

A Snapshot of the Condition of Upper Chapman Brook 2012/2013

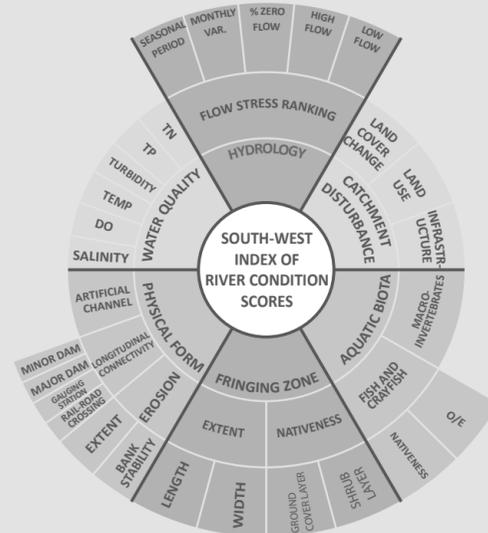
Methods for Assessing River Condition

Assessments were made using the South West Index of River Condition (SWIRC), which provides a suite of standardised methods for collecting field and desktop data, as well as protocols for analysing the data. It includes a scoring system to measure departure from natural conditions and to allow comparison between river systems. Scores are categorised on a scale between 'largely unmodified' and 'severely modified'.

The SWIRC uses a series of indicators to examine six broad ecological themes that underpin ecological condition of waterways. Assessments are completed at a reach scale, with some data gathered at sampling site(s) which are representative of the reach.

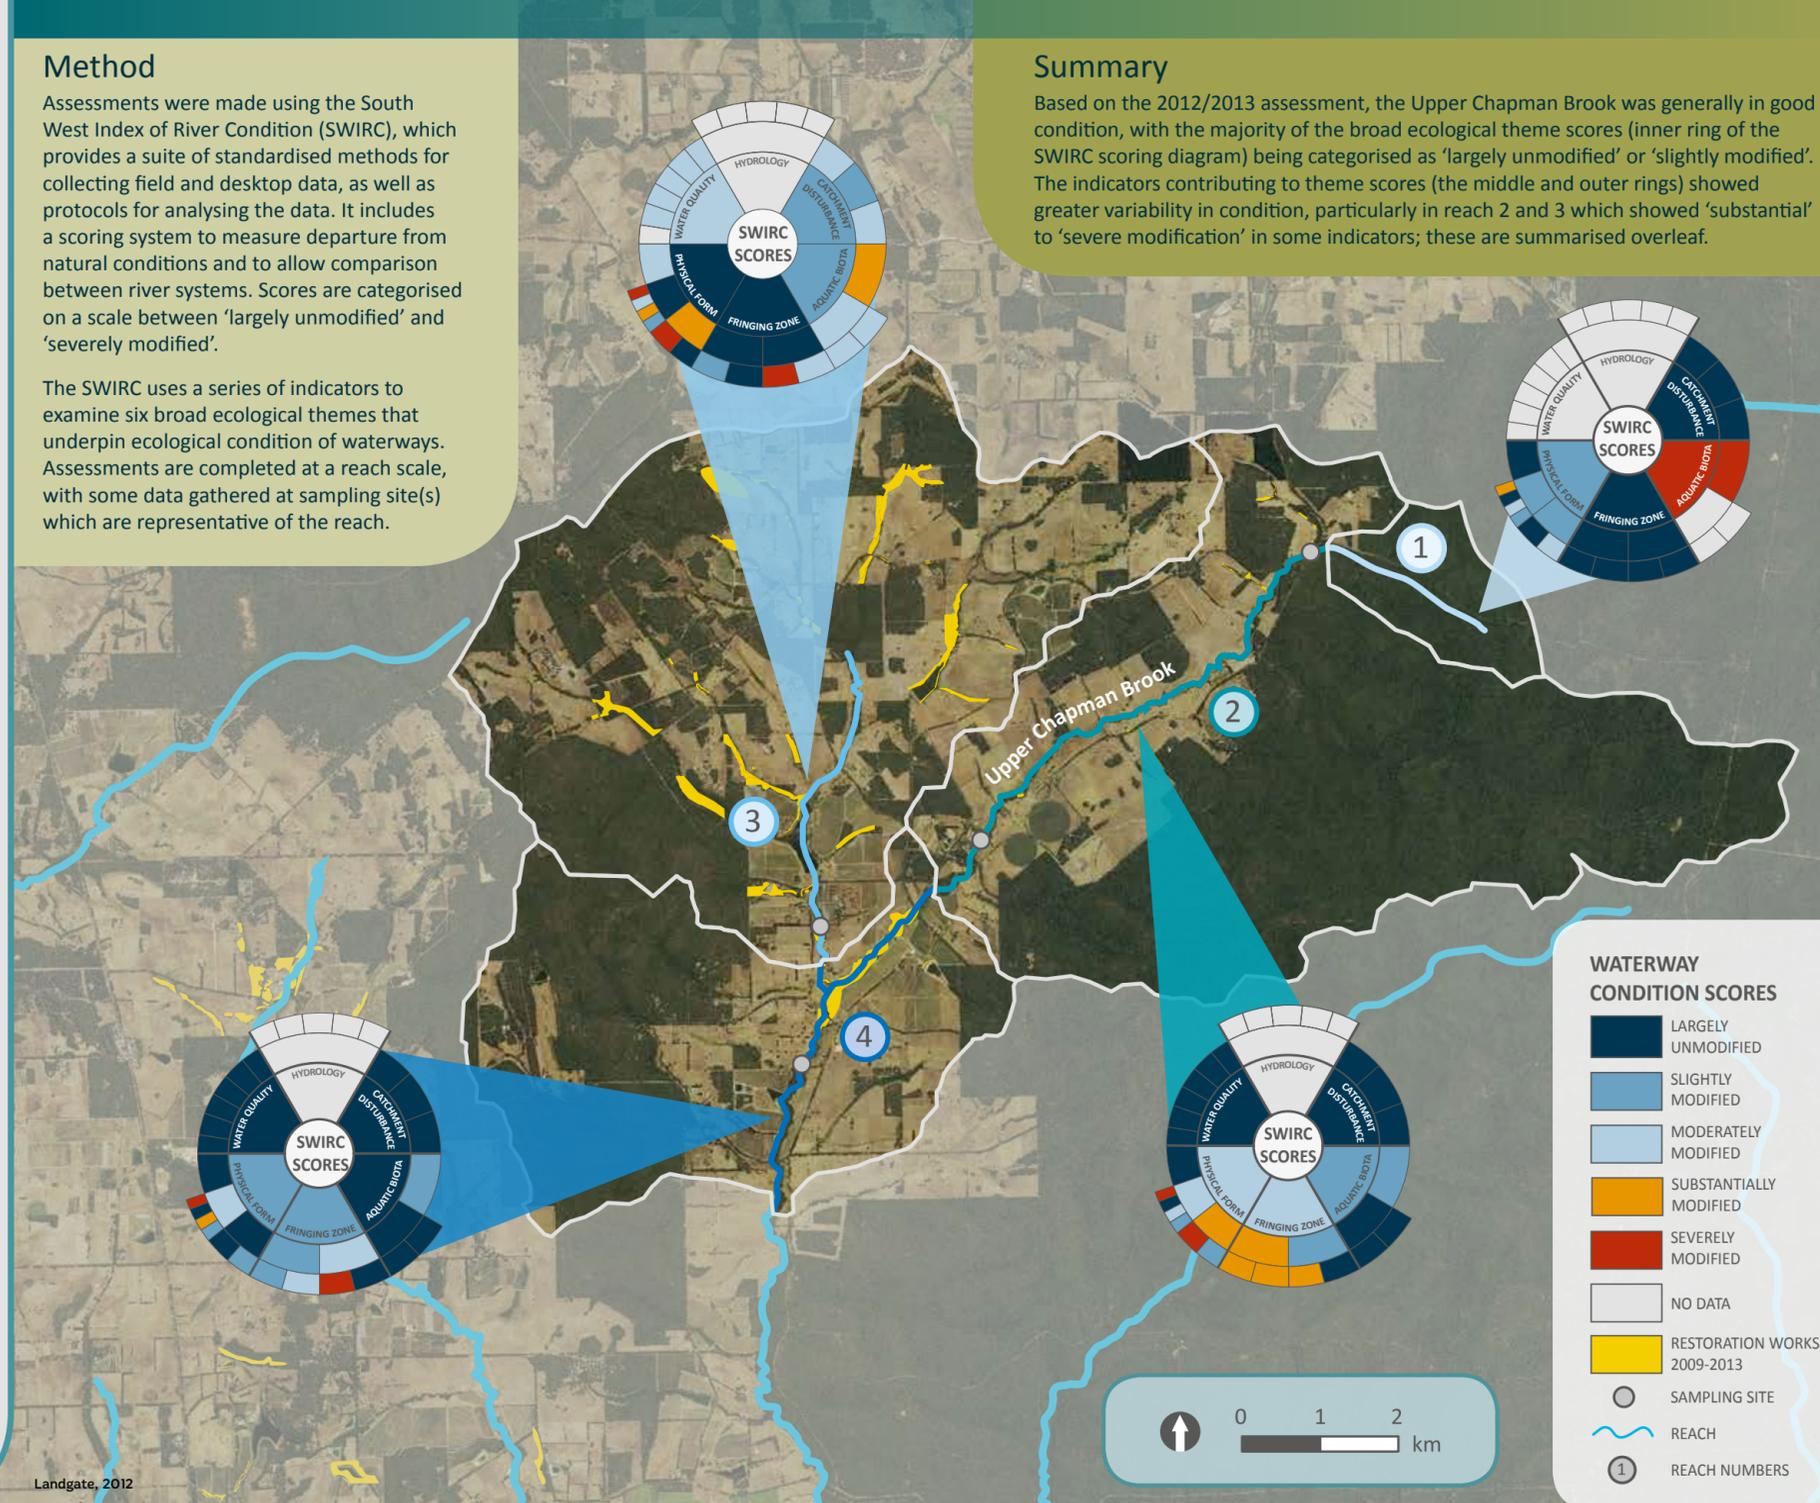
WATERWAY CONDITION SCORES

Based on the 2012/2013 assessment, the Upper Chapman Brook was generally in good condition, with the majority of the broad ecological theme scores (inner ring of the SWIRC scoring diagram) being categorised as 'largely unmodified' or 'slightly modified'. The indicators contributing to theme scores (the middle and outer rings) showed greater variability in condition, particularly in reach 2 and 3 which showed 'substantial' to 'severe modification' in some indicators; these are summarised overleaf.
